**Flood Control Project Maintenance  
Levee Inspections**

## Maintenance Issue Types Only, Levee Inspection Report By Mile - Spring 2016

### Reclamation District No. 0563 Tyler Island

Waterway	Bank	Unit Miles	Inspection Start/End	Inspector
Unit No. 01 Georgiana Slough (Tyler Island)	Left	12.11	03/28/2016 03/28/2016	Richard Willoughby

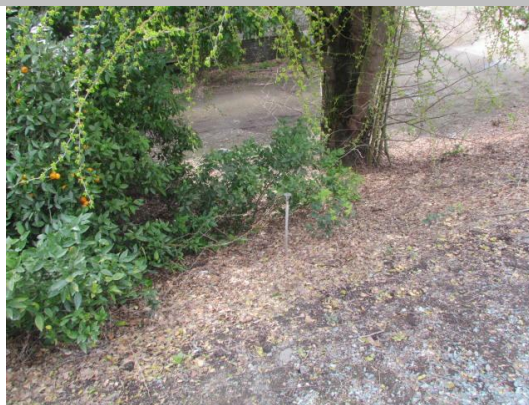
Photo 1 of 2 : SP\_2016\_RD0563\_210\_28\_20160308\_00029.jpg

Looking east at sprinklers on landside slope.

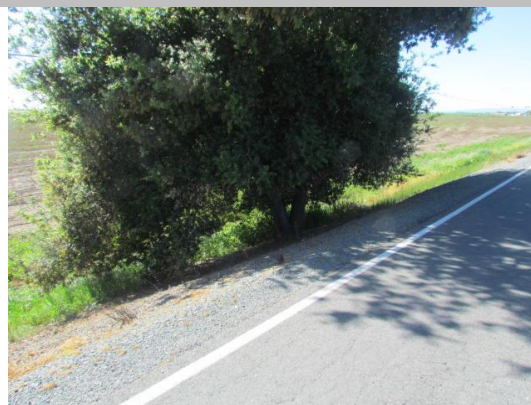
Photo 1 of 1 : SP\_2016\_RD0563\_210\_135\_20160330\_00228.jpg

Looking southeast at untrimmed tree on landward slope.

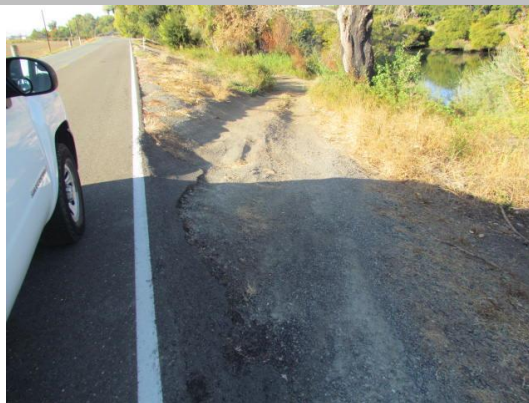
Photo 1 of 1 : SP\_2016\_RD0563\_210\_16\_20160308\_00020.jpg

LM Start	0.39	Rating **	M	Issue No.	16
LM End	0.39	Issue Type +	Ma	Location *	WS
Category	Earthen Levee			GPS Latitude/Longitude	
				Start	End
Item	Slope Stability			38.230841 °	38.230841 °
				-121.521898 °	-121.521898 °
DWR ID	DWR_RD0563_01_f_2013_16				
Comment Code					
S3 : Repair the levee slope damaged by vehicle traffic and prevent access where possible.					
Inspector Comment					
Slope damage is due to fishermen vehicle traffic.

Looking southwest at slope damage caused by vehicle traffic.

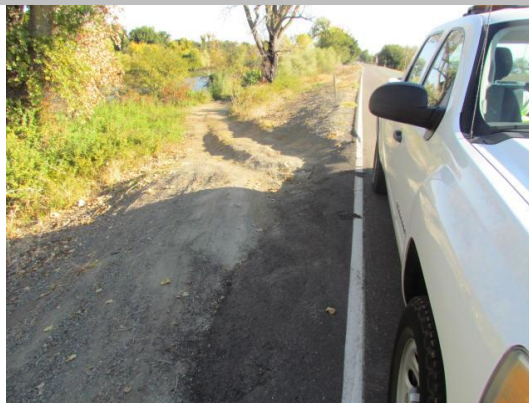
Photo 1 of 1 : SP\_2016\_RD0563\_210\_26\_20160308\_00027.jpg

LM Start	0.43	Rating **	M	Issue No.	26
LM End	0.43	Issue Type +	Ma	Location *	WS
Category	Earthen Levee			GPS Latitude/Longitude	
				Start	End
Item	Slope Stability			38.230460 °	38.230460 °
				-121.522324 °	-121.522324 °
DWR ID	DWR_RD0563_01_f_2013_26				
Comment Code					
S3 : Repair the levee slope damaged by vehicle traffic and prevent access where possible.					
Inspector Comment					
Slope damage due to fishermen vehicle traffic.

Looking northwest at slope damage caused by vehicle traffic.

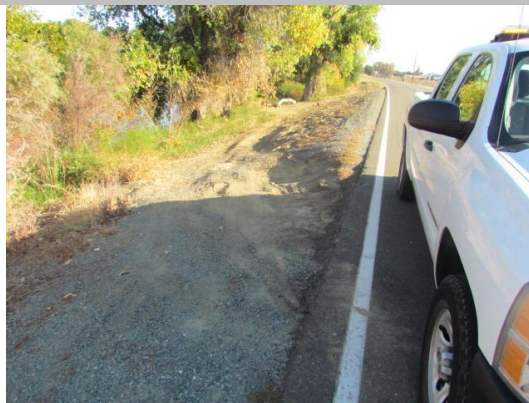
Photo 1 of 1 : SP\_2016\_RD0563\_210\_34\_20160308\_00035.jpg

LM Start	0.56	Rating **	M	Issue No.	34
LM End	0.56	Issue Type +	Ma	Location *	WS
Category	Earthen Levee			GPS Latitude/Longitude	
				Start	End
Item	Slope Stability			38.228948 °	38.228948 °
				-121.523904 °	-121.523904 °
DWR ID	DWR_RD0563_01_f_2013_34				
Comment Code					
S3 : Repair the levee slope damaged by vehicle traffic and prevent access where possible.					
Inspector Comment					
Slope damage is due to fishermen vehicle traffic.

Looking northwest at slope damage caused by vehicle traffic.

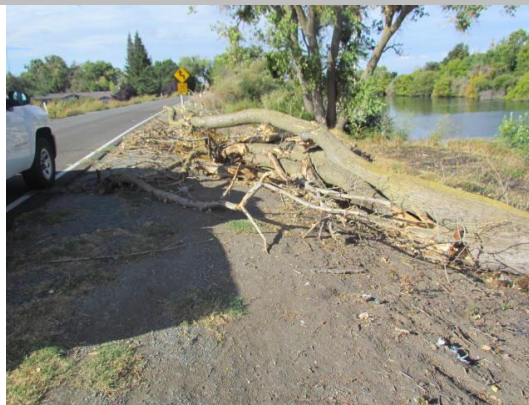
Photo 2 of 5 : SP\_2016\_RD0563\_210\_139\_20160308\_00121.jpg

LM Start	0.60	Rating **	U	Issue No.	139
LM End	0.60	Issue Type +	Ma	Location *	WS
Category	Earthen Levee			GPS Latitude/Longitude	
				Start	End
Item	Encroachments			38.228605 °	38.228605 °
				-121.524364 °	-121.524364 °
DWR ID	DWR_RD0563_01_f_2015_139				
Comment Code					
TR : Tree or limb					
Inspector Comment					
Large fallen tree on waterward slope. Fallen tree left large hole on waterward berm.

Looking south at fallen tree on waterward slope.

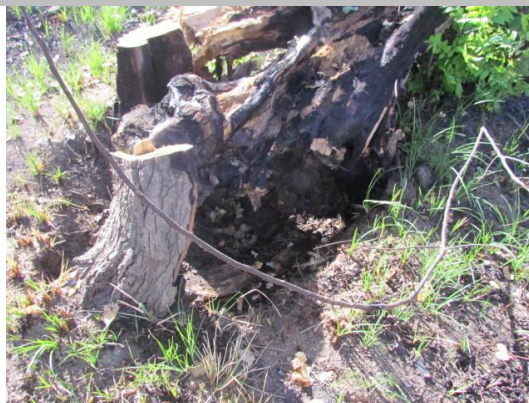
Photo 5 of 5 : SP\_2016\_RD0563\_210\_139\_20160308\_00124.jpg

Looking at large hole left by fallen tree on waterward berm.

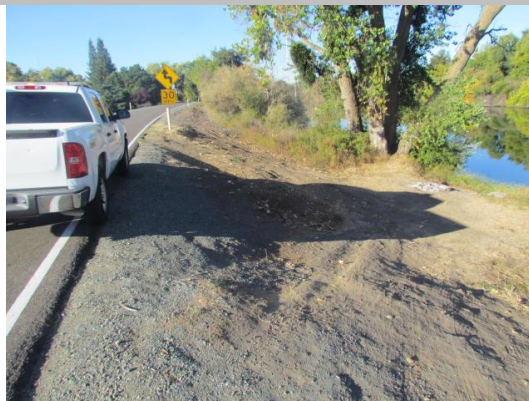
Photo 1 of 2 : SP\_2016\_RD0563\_210\_143\_20160308\_00129.jpg

LM Start	0.61	Rating **	M	Issue No.	143
LM End	0.61	Issue Type +	Ma	Location *	WS
Category	Earthen Levee			GPS Latitude/Longitude	
				Start	End
Item	Slope Stability			38.228507 °	38.228507 °
				-121.524543 °	-121.524543 °
DWR ID	DWR_RD0563_01_f_2014_143				
Comment Code					
S3 : Repair the levee slope damaged by vehicle traffic and prevent access where possible.					
Inspector Comment					
Slope damage due to vehicle traffic.

Looking southeast at slope damage on waterward slope.

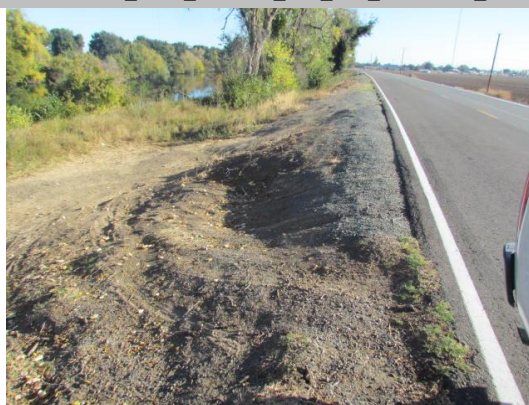
Photo 2 of 2 : SP\_2016\_RD0563\_210\_143\_20160308\_00130.jpg

Looking northwest at slope damage on waterward slope.

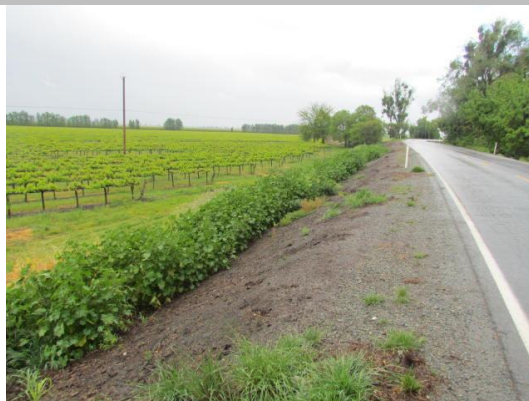
Photo 1 of 1 : SP\_2016\_RD0563\_210\_754\_20160308\_00139.jpg

LM Start	0.72	Rating **	A/W	Issue No.	754
LM End	0.79	Issue Type +	Ma	Location *	LS
Category	Earthen Levee			GPS Latitude/Longitude	
				Start	End
Item	Vegetation			38.227287 °	38.226376 °
				-121.525832 °	-121.525908 °
DWR ID	DWR_RD0563_01_s_2015_754				
Comment Code					
V2 : Remove the wild growth other than native grasses from the levee slopes.					
Inspector Comment

Looking southeast at dense vegetation at landward toe.

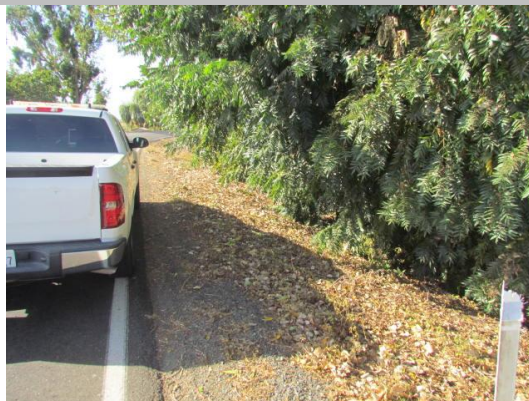
Photo 1 of 1 : SP\_2016\_RD0563\_210\_3\_20160308\_00001.jpg

Looking south at untrimmed trees on waterward slope and toe.

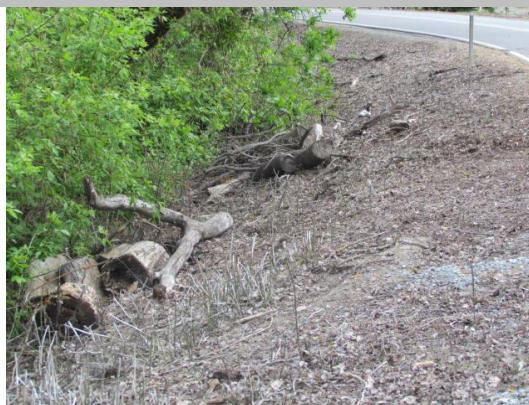
Photo 1 of 2 : SP\_2016\_RD0563\_210\_9\_20160308\_00009.jpg

LM Start	0.84	Rating **	A/W	Issue No.	9
LM End	0.84	Issue Type +	Ma	Location *	WS
Category	Earthen Levee			GPS Latitude/Longitude	
				Start	End
Item	Encroachments			38.225685 °	38.225685 °
				-121.526288 °	-121.526288 °
DWR ID	DWR_RD0563_01_s_2012_9				
Comment Code					
PR : Prunings					
Inspector Comment					
Prunings on waterside slope should be burned or removed.

Looking northeast at tree limbs on waterward slope.

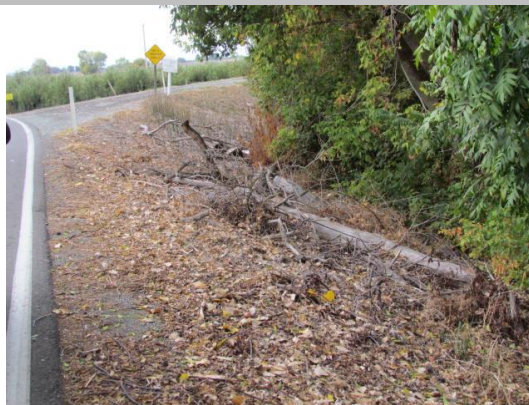
Photo 2 of 2 : SP\_2016\_RD0563\_210\_9\_20160308\_00010.jpg

Looking southwest at tree limbs on waterside slope.

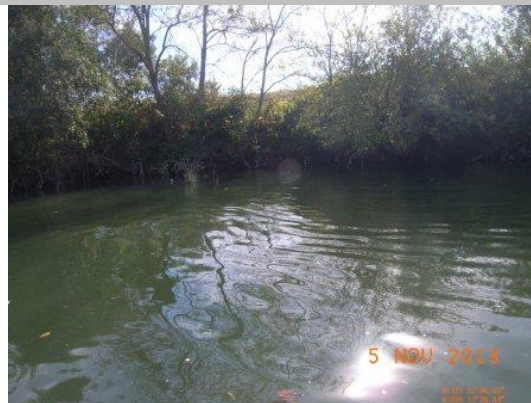
Photo 1 of 1 : SP\_2016\_RD0563\_210\_48\_20160308\_00047.jpg

LM Start	1.02	Rating **	M	Issue No.	48
LM End	1.11	Issue Type +	Ma	Location *	WS
Category	Supplemental			GPS Latitude/Longitude	
				Start	End
Item	2015 USACE Erosion Survey, DRAFT			38.226522 °	38.227157 °
				-121.529094 °	-121.530432 °
DWR ID	DWR_RD0563_01_s_2016_48				
Comment Code					
Inspector Comment					
2011 - Short sections of eroding bank at the waterline and holes in toe of levee. 2012 - Site extended upstream. 2013 - Erosion pockets filled with an insufficient amounts of revetment. 2015: Last observed in 2013. [2015 Site ID: GEO_11-0_L]

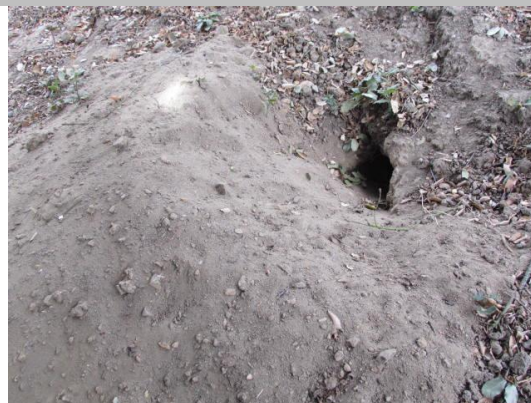
Photo 1 of 1 : SP\_2016\_RD0563\_210\_153\_20160308\_00135.jpg

LM Start	1.15	Rating **	U	Issue No.	153
LM End	1.15	Issue Type +	Ma	Location *	LS
Category	Earthen Levee			GPS Latitude/Longitude	
				Start	End
Item	Animal Control			38.226910 °	38.226910 °
				-121.531294 °	-121.531294 °
DWR ID	DWR_RD0563_01_f_2015_153				
Comment Code					
A3 : No rodents visible, but rodent burrows visible; need to backfill and compact or grout burrows.					
Inspector Comment					
Several large to medium rodent holes noted.

Looking at typical view of several rodent holes on landward slope.

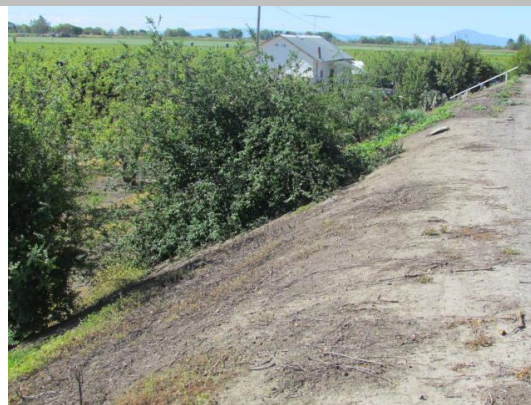
Photo 1 of 1 : SP\_2016\_RD0563\_210\_7\_20160330\_00239.jpg

Looking southeast at untrimmed tree at landward toe.

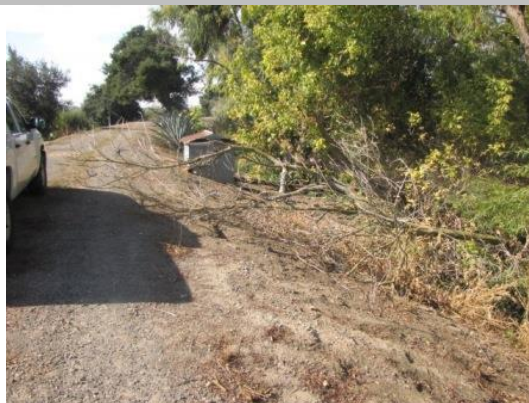
Photo 1 of 1 : SP\_2016\_RD0563\_210\_19\_20160308\_00022.jpg

LM Start	1.39	Rating **	M	Issue No.	19
LM End	1.39	Issue Type +	Ma	Location *	WS
Category	Earthen Levee			GPS Latitude/Longitude	
				Start	End
Item	Encroachments			38.224367 °	38.224367 °
				-121.534165 °	-121.534165 °
DWR ID	DWR_RD0563_01_s_2012_19				
Comment Code					
TR : Tree or limb					
Inspector Comment					
Broken tree along waterside slope.

Looking south at a downed tree on waterside slope.

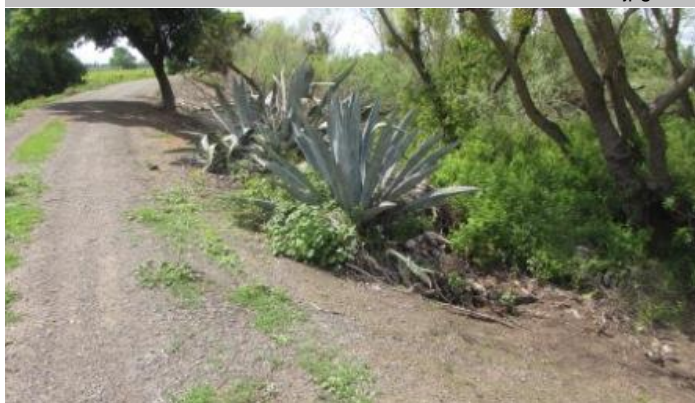
Photo 1 of 2 : SP\_2016\_RD0563\_210\_6\_20160308\_00004.jpg

Updated view looking upstream at a century plant on waterside shoulder slope.

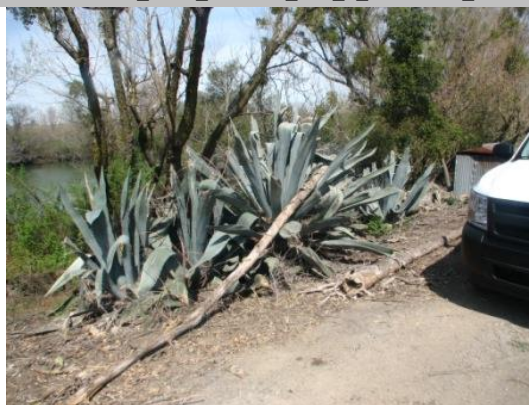
Photo 2 of 2 : SP\_2016\_RD0563\_210\_6\_20160308\_00005.jpg

Century plant on waterward shoulder at LM 1.42

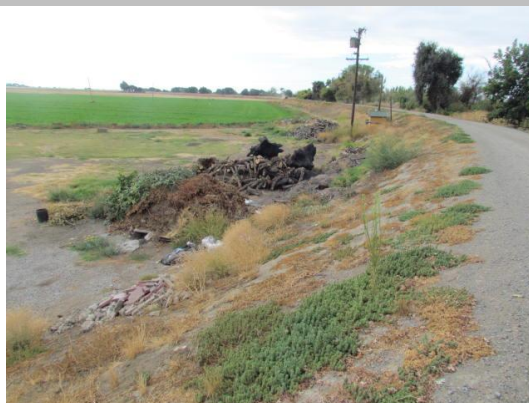
Photo 1 of 2 : SP\_2016\_RD0563\_210\_96\_20160308\_00105.jpg

LM Start	1.92	Rating **	A/W	Issue No.	96
LM End	1.92	Issue Type +	Ma	Location *	LS
Category	Earthen Levee			GPS Latitude/Longitude	
				Start	End
Item	Encroachments			38.222299 °	38.222299 °
				-121.543366 °	-121.543366 °
DWR ID	DWR_RD0563_01_f_2013_96				
Comment Code					
PR : Prunings					
Inspector Comment					
Large pruning pile at landward toe. Landowner has burned pile, but pile is still within right away.

Looking south at pruning piles at landward toe. (Fall 2015)

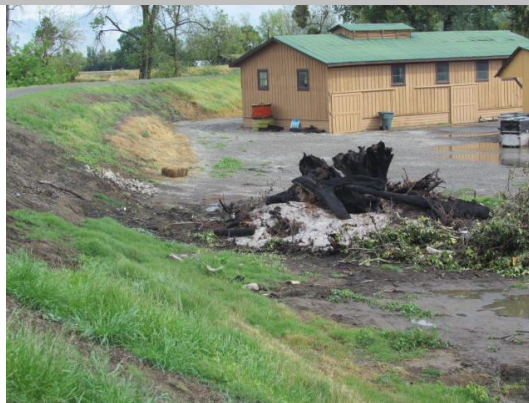
Photo 2 of 2 : SP\_2016\_RD0563\_210\_96\_20160308\_00106.jpg

Looking north at partially burned pruning pile at landward toe. (Spring 2015)

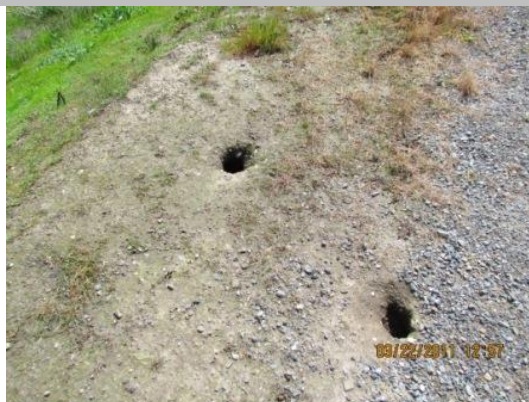
Photo 1 of 1 : SP\_2016\_RD0563\_210\_33\_20160308\_00034.jpg

Looking southeast at squirrel holes on landside shoulder.

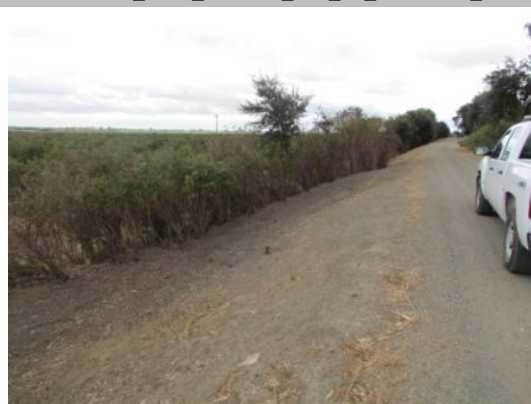
Photo 1 of 2 : SP\_2016\_RD0563\_210\_11\_20160308\_00014.jpg

Look southeast at updated (10/11) view of elderberries on landside slope.

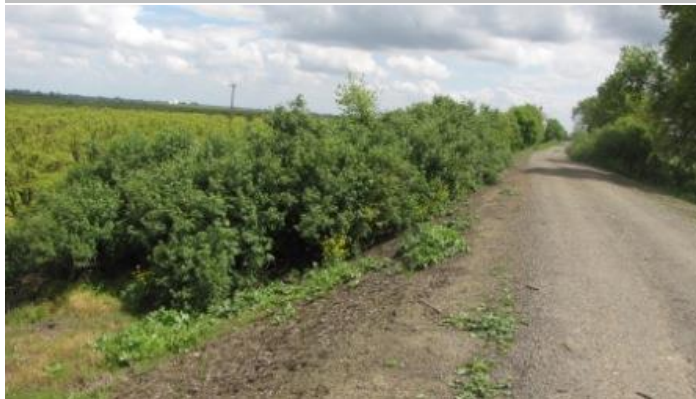
Photo 2 of 2 : SP\_2016\_RD0563\_210\_11\_20160308\_00015.jpg

Looking southeast at elderberry on the landside slope and toe.

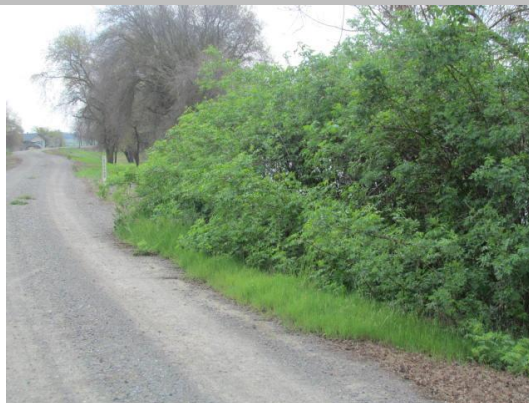
Photo 2 of 2 : SP\_2016\_RD0563\_210\_12\_20160308\_00017.jpg

Looking southwest at dense elderberry on waterside shoulder and slope.  
(Fall 2014)

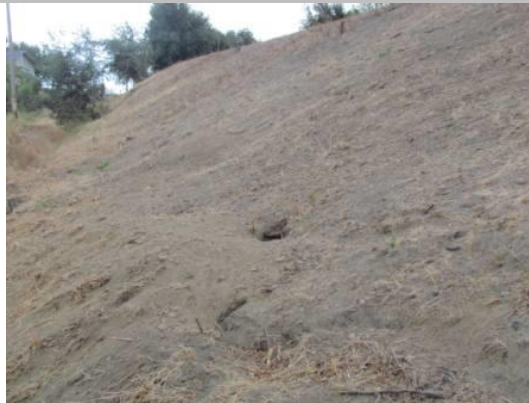
Photo 3 of 4 : SP\_2016\_RD0563\_210\_85\_20160308\_00089.jpg

Looking southwest at rodent holes on landside slope.

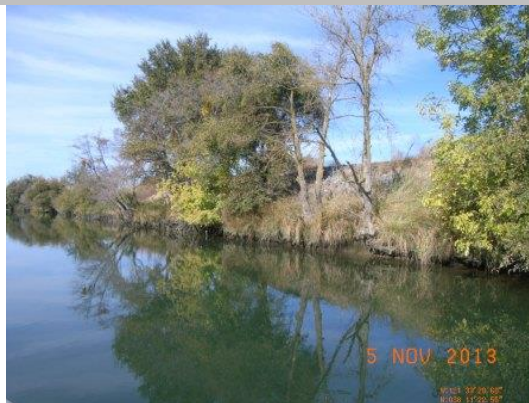
Photo 1 of 1 : SP\_2016\_RD0563\_210\_39\_20160308\_00038.jpg

LM Start	2.61	Rating **	M	Issue No.	39
LM End	2.82	Issue Type +	Ma	Location *	WS
Category	Supplemental			GPS Latitude/Longitude	
				Start	End
Item	2015 USACE Erosion Survey, DRAFT			38.214133 °	38.211737 °
				-121.537778 °	-121.535436 °
DWR ID	DWR_RD0563_01_s_2016_39				
Comment Code					
Inspector Comment					
1997 - Loss of rock at toe; pockets of upper berm erosion; very narrow berm width; toe rock problem; erosion pockets in rock. 2002 - New brush boxes at toe of the worst spots. 2005 - Upstream 200 ft removed because of the wide berm. 2006 - Some rock repair pockets behind the brush boxes at the upstream end. 2010 - Some new erosion. 2013 - New rock placed on the levee slope. 2015: Last observed in 2013. [2015 Site ID: GEO_9-3_L]

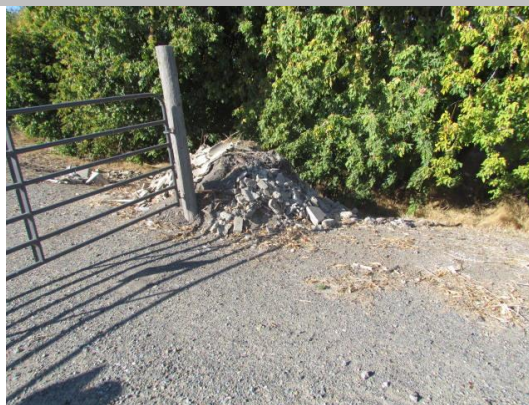
Photo 1 of 2 : SP\_2016\_RD0563\_210\_104\_20160308\_00115.jpg

Looking west at concrete rubble on waterward shoulder and slope.

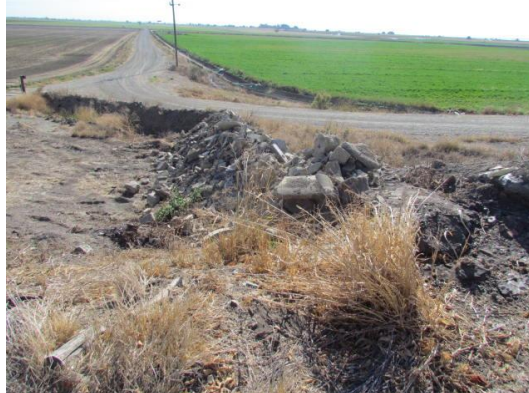
Photo 2 of 2 : SP\_2016\_RD0563\_210\_104\_20160308\_00116.jpg

Looking east at concrete rubble on landward slope.

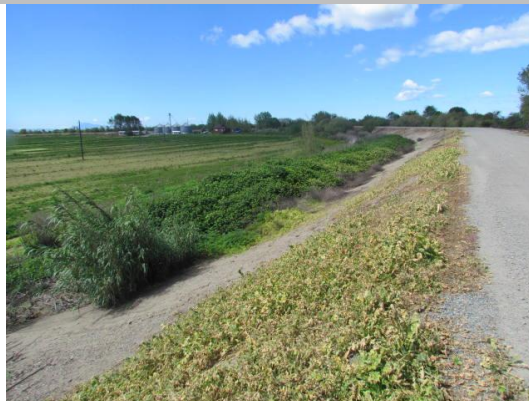
Photo 1 of 4 : SP\_2016\_RD0563\_210\_74\_20160330\_00244.jpg

Looking southeast at berryvines at landward toe., (Spring 2016)

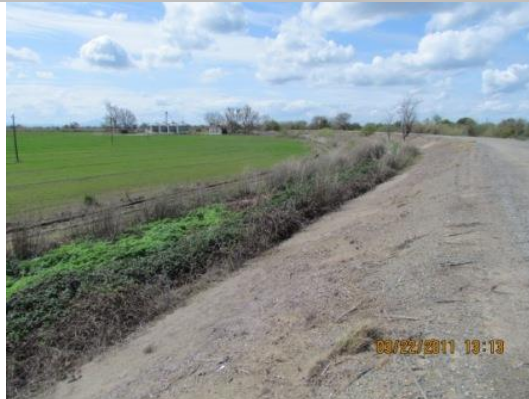
Photo 4 of 4 : SP\_2016\_RD0563\_210\_74\_20160308\_00069.jpg

Looking southeast at berryvines on landside toe. (Fall 2014)

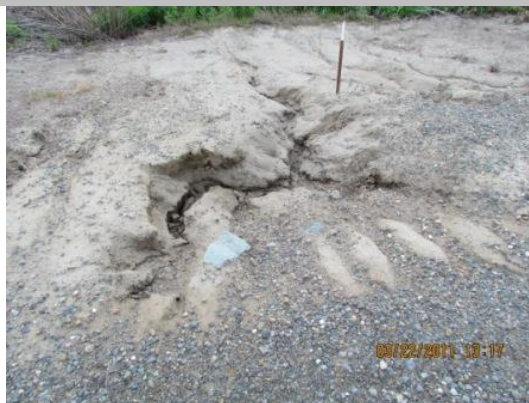
Photo 2 of 5 : SP\_2016\_RD0563\_210\_78\_20160308\_00077.jpg

Looking east at slope erosion cause by runoff on landside slope.

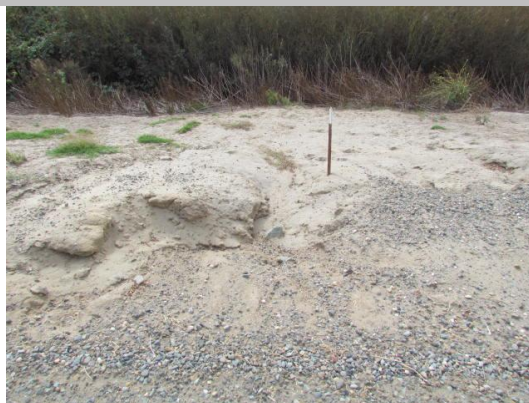
Photo 3 of 5 : SP\_2016\_RD0563\_210\_78\_20160308\_00078.jpg

Looking east at slope damage on 10/31/2012, no change in status.

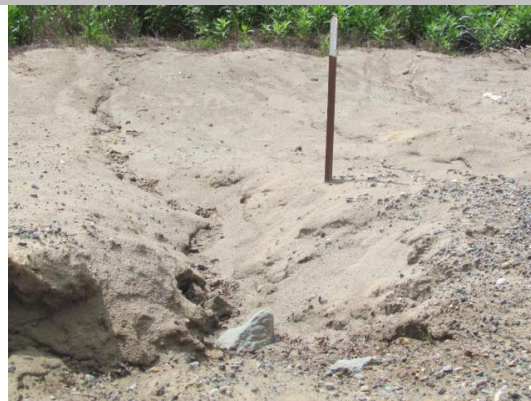
Photo 4 of 5 : SP\_2016\_RD0563\_210\_78\_20160308\_00079.jpg

Looking east at slope erosion. (Updated Spring 2012)

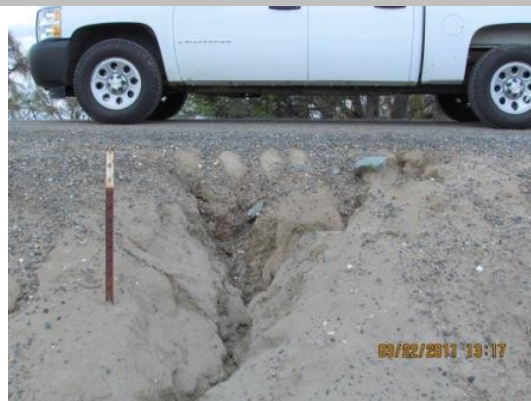
Photo 5 of 5 : SP\_2016\_RD0563\_210\_78\_20160308\_00080.jpg

Looking west at slope erosion cause by runoff on landside slope.

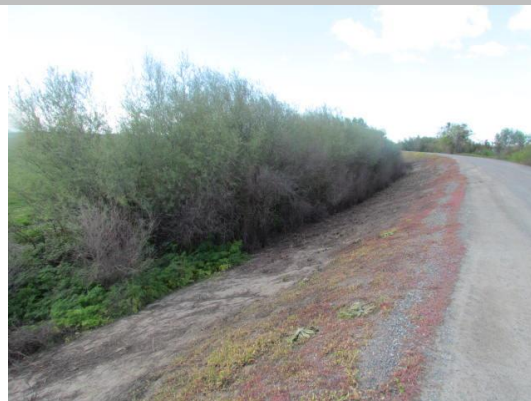
Photo 1 of 2 : SP\_2016\_RD0563\_210\_763\_20160330\_00248.jpg

Looking south at dense vegetation (willows) at landward toe. (Spring 2016)

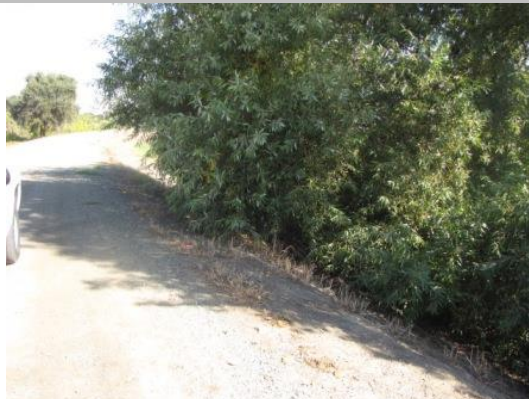
Photo 2 of 2 : SP\_2016\_RD0563\_210\_68\_20160308\_00062.jpg

Looking southeast at dense trees on landside slope and toe.

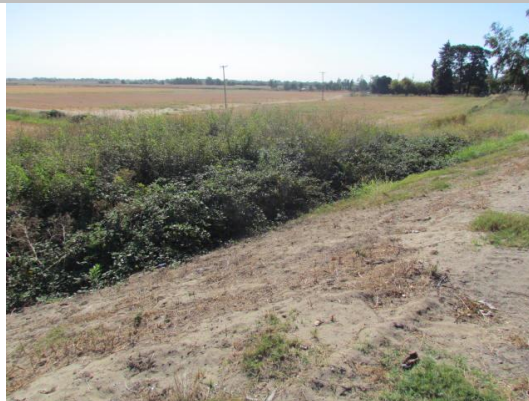
Photo 2 of 2 : SP\_2016\_RD0563\_210\_84\_20160308\_00086.jpg

Looking southeast at dense berryvines on landward toe.

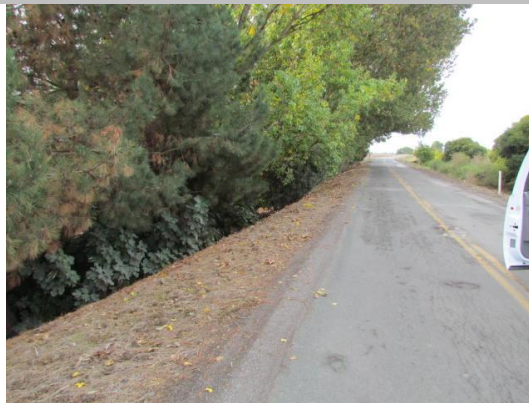
Photo 1 of 1 : SP\_2016\_RD0563\_210\_88\_20160308\_00093.jpg

Looking south at dense trees on landside slope and toe.

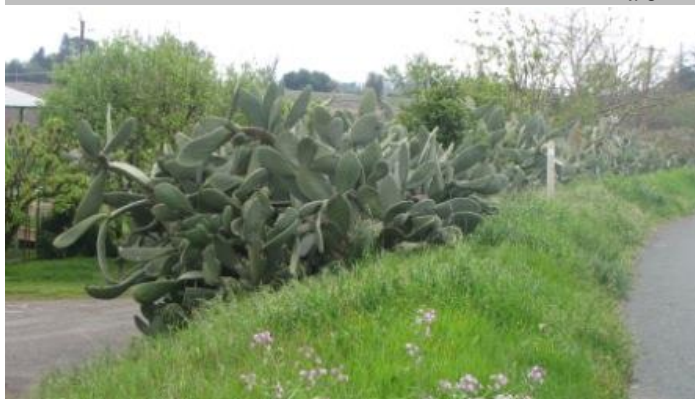
Photo 1 of 2 : SP\_2016\_RD0563\_210\_22\_20160308\_00023.jpg

Looking at north end of cactus on the landside slope.

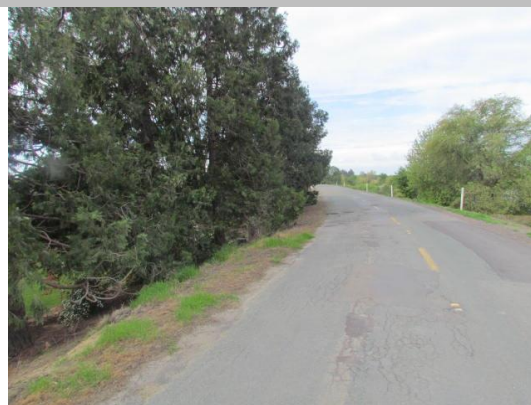
Photo 1 of 1 : SP\_2016\_RD0563\_210\_23\_20160308\_00025.jpg

Looking south at trees on landward shoulder.

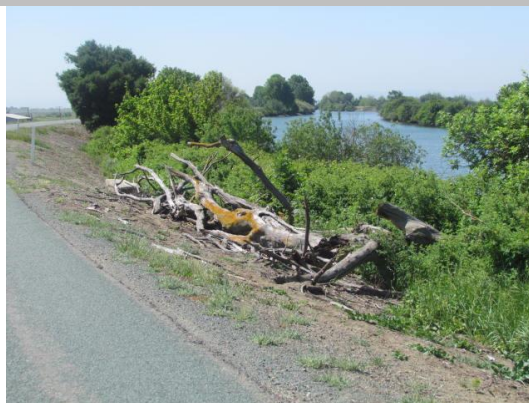
Photo 1 of 1 : SP\_2016\_RD0563\_210\_95\_20160308\_00104.jpg

Looking southwest at prunings on waterward slope.

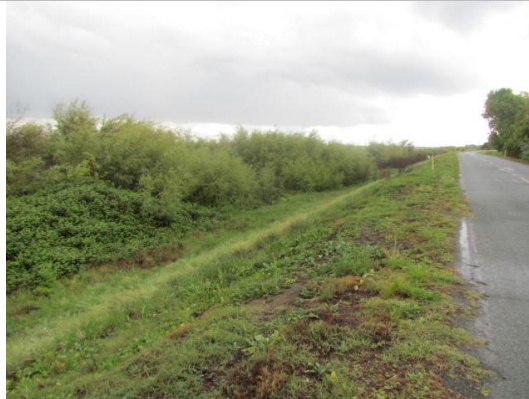
Photo 1 of 1 : SP\_2016\_RD0563\_210\_27\_20160308\_00028.jpg

Looking southeast at dense vegetation within landward right away.

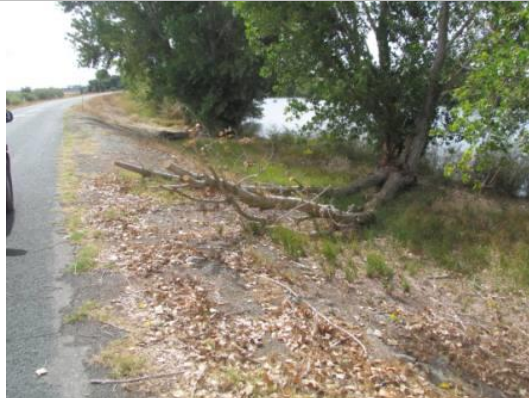
Photo 1 of 1 : SP\_2016\_RD0563\_210\_89\_20160308\_00094.jpg

Looking southwest at downed limbs on waterside slope.

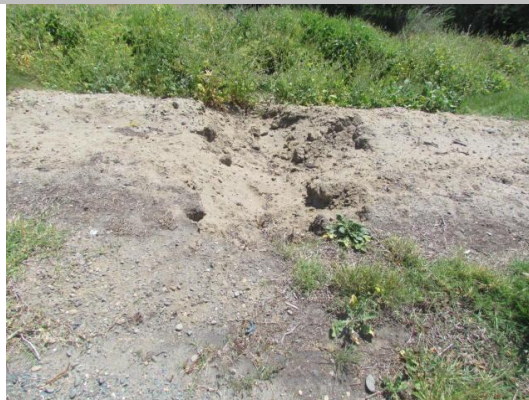
Photo 1 of 1 : SP\_2016\_RD0563\_210\_97\_20160308\_00107.jpg

Looking east at slope erosion on landward shoulder and slope.

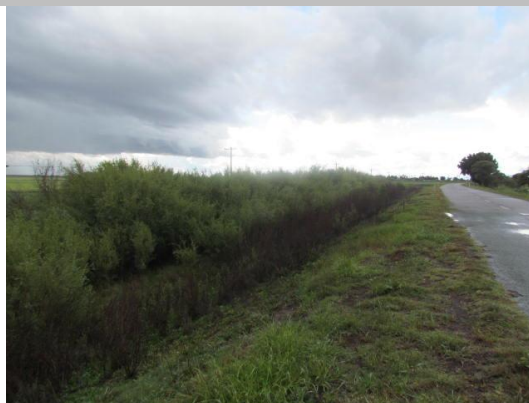
Photo 1 of 5 : SP\_2016\_RD0563\_210\_90\_20160308\_00095.jpg

Looking southeast at dense vegetation at landward toe. (Spring 2015)

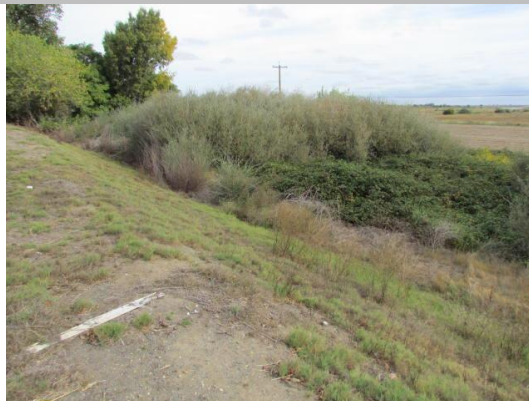
Photo 4 of 5 : SP\_2016\_RD0563\_210\_90\_20160308\_00098.jpg

Looking northeast at dense vegetation on landside toe. (2012 Fall Inspection)

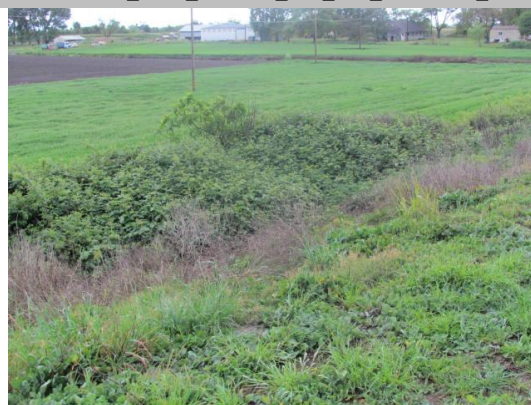
Photo 1 of 1 : SP\_2016\_RD0563\_210\_767\_20160308\_00142.jpg

Looking east at dense wild vines at landward toe.

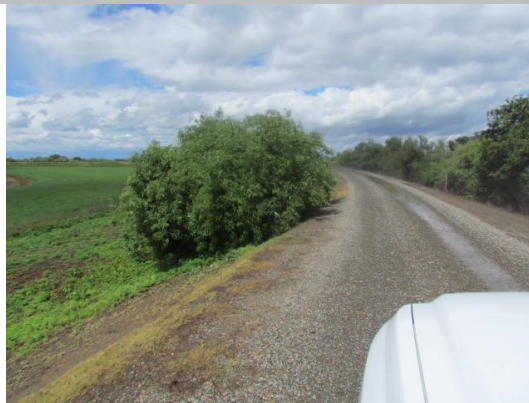
Photo 1 of 1 : SP\_2016\_RD0563\_210\_36\_20160308\_00036.jpg

Looking south at elderberry on landward slope.

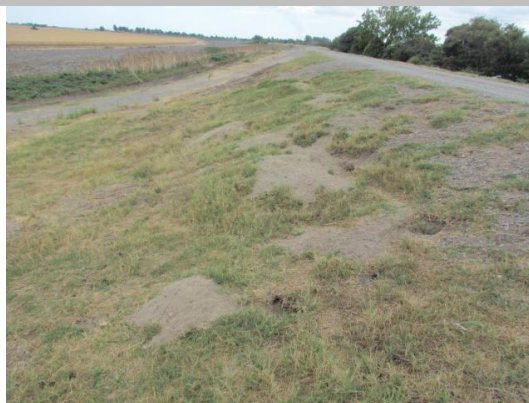
Photo 3 of 4 : SP\_2016\_RD0563\_210\_77\_20160308\_00075.jpg

Looking south at several rodent holes on landward slope.

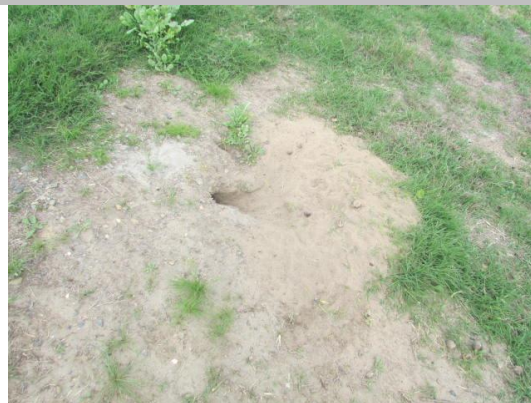
Photo 4 of 4 : SP\_2016\_RD0563\_210\_77\_20160308\_00076.jpg

Looking at typical rodent holes on landward slope.

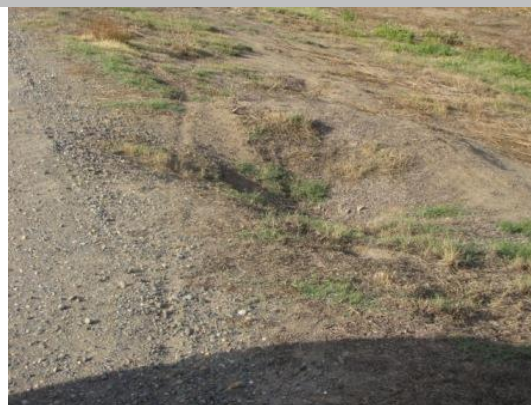
Photo 1 of 4 : SP\_2016\_RD0563\_210\_76\_20160308\_00070.jpg

Looking northeast a depression on landside shoulder and slope above 10" irrigation pipe four feet below crown.

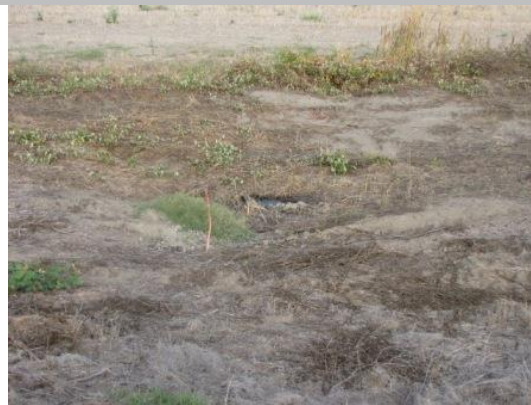
Photo 2 of 4 : SP\_2016\_RD0563\_210\_76\_20160308\_00071.jpg

Looking east at water ponding at landside toe just above 10" irrigation pipe.

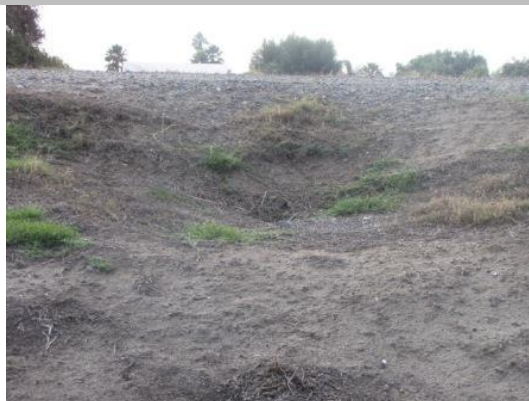
Photo 3 of 4 : SP\_2016\_RD0563\_210\_76\_20160308\_00072.jpg

Looking west at depression on landside shoulder and slope from landside toe.

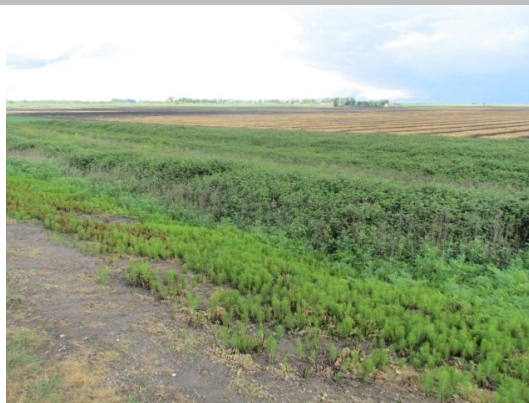
Photo 1 of 3 : SP\_2016\_RD0563\_210\_100\_20160308\_00111.jpg

Looking northeast at dense vegetation at landward toe. (Spring 2015)

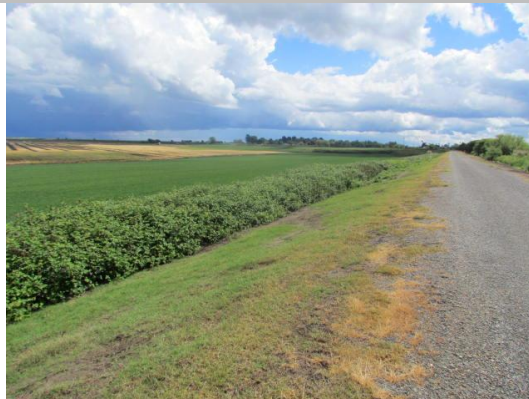
Photo 1 of 1 : SP\_2016\_RD0563\_210\_770\_20160308\_00144.jpg

Looking southeast at dense vegetation at landward toe. (Spring 2015)

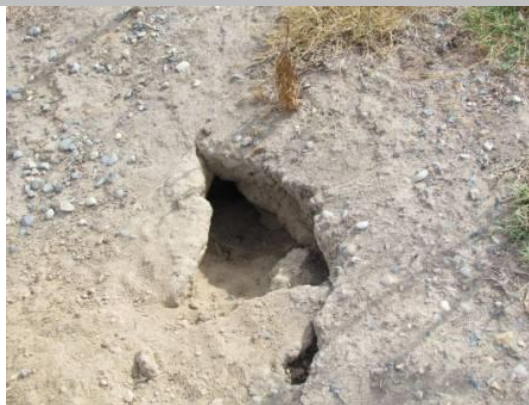
Photo 1 of 3 : SP\_2016\_RD0563\_210\_91\_20160308\_00100.jpg

Looking east at rodent hole on landside slope.

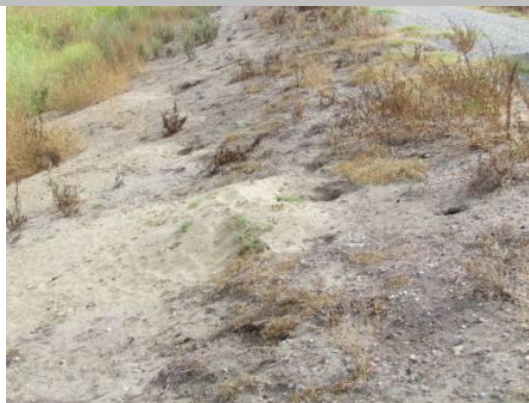
Photo 3 of 3 : SP\_2016\_RD0563\_210\_91\_20160308\_00102.jpg

Looking south at rodent holes on landside slope.

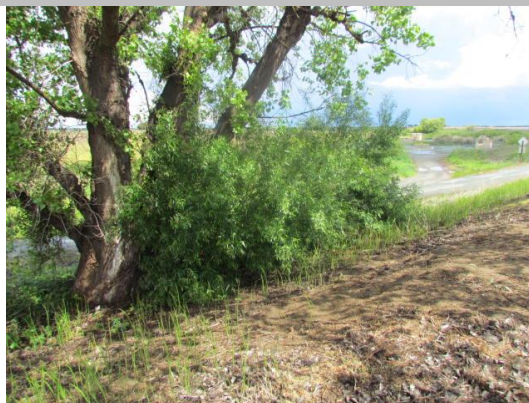
Photo 1 of 1 : SP\_2016\_RD0563\_210\_47\_20160308\_00046.jpg

Looking east at untrimmed tree at landward slope. (Spring 2015)
